## **LARGE-SCALE PATTERNS IN LARGE WOODY DEBRIS AND UPLAND VEGETATION AMONG ARMORED AND UNARMORED SHORELINES OF PUGET SOUND, WA.**

Dr. Kirstin K. Holsman  
*People For Puget Sound, Seattle*

Justin Willig  
*School of Aquatic & Fishery Sciences, University of Washington*

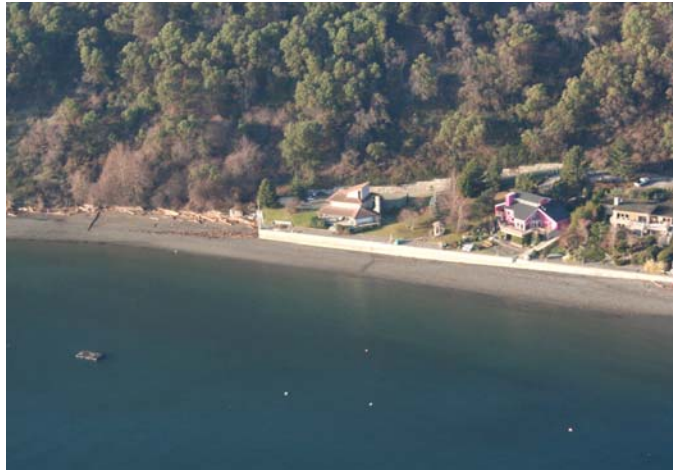
Figure 1. Image of natural (on left) and armored (right) shorelines.

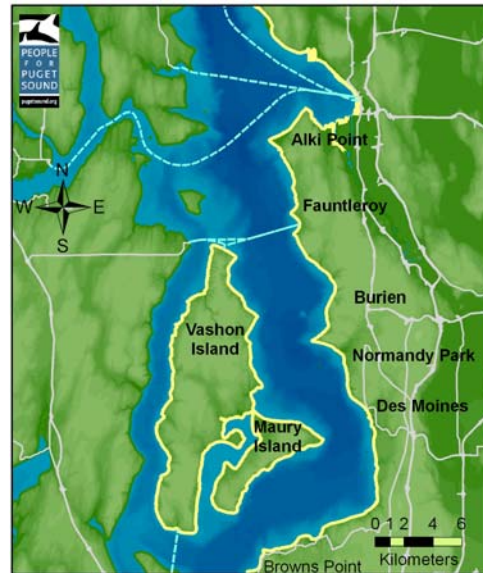
Figure 2. WRIA 9 study area (yellow). Surveys sampled shorelines of Seattle, Burien, Normandy Park, Des Moines, Federal Way, as well as Vashon and Maury Islands.

Aerial photographs were collected during low altitude surveys of nearshore beaches in WRIA 9 on December 29, 2006 (Fig. 2). WRIA 9 includes the Green/ Duwamish and Central Puget Sound Watershed, and this study focused on over 141 miles of shoreline (Higgins et al. 2005) along Seattle, Burien, Normandy Park, Des Moines, Federal Way, and also Vashon, and Maury Islands. Oblique photographs were taken at 1500 ft using a high-resolution handheld digital SLR camera. Spatial information (latitude and longitude) was collected with a handheld GPS (Garmin Map 60C). Photos were post-processed using GIS software and analyzed to estimate the abundance of LWD and collect corresponding information on upland characteristics. A subsequent survey was also conducted on February 12, 2007 to collect ortho-like photos for GIS analyses; these analyses are ongoing and will not be described in this report.

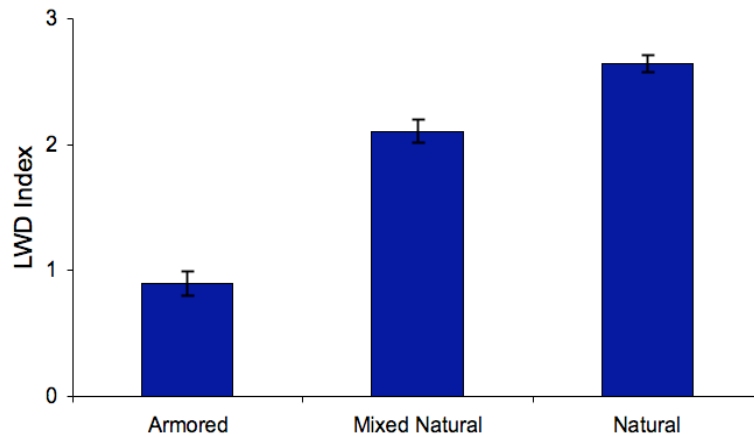
Figure 4. Mean abundance indices (Low=1, Med=2, High=3) of large woody debris (LWD) in photos with shorelines characterized by riprap revetments or vertical bulkheads (Armored), natural and armored shorelines (Mixed Natural), and unarmored shorelines (natural). Error bars represent standard error of the mean.

Of the 289 photos we evaluated, 70% contained shorelines with either riprap revetments or vertical bulkheads. Natural features including abundance of LWD, nearshore vegetation, and overhanging trees also varied markedly between photos characterized by natural or armored shorelines. LWD abundance indices were greatest in photos with natural shorelines indicating that LWD is most abundant on natural shorelines and least abundant on armored shorelines (Fig. 4). Overhanging

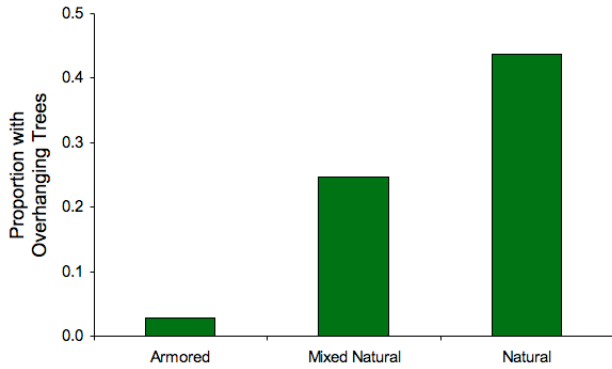
Figure 5. Proportion of all photographs with shorelines characterized by riprap revetments or vertical bulkheads (“armored”), natural and armored shorelines (“mixed natural”), and unarmored shorelines (“natural”) that contained trees overhanging the upper intertidal zone.

vegetation was most frequently observed in photos characterized by natural shorelines and rarely observed in photos where shorelines were completely armored (Fig. 5). Patterns in upland characteristics were strongly correlated with shoreline armoring. More than 60% of photos characterized by unarmored shorelines were dominated by trees and shrubs (Fig. 6, 7). In contrast, less than 5% of photos with extensive armoring were dominated by trees and shrubs, in these photos most upland areas were dominated by lawns (“grass”) and semi-manicured landscapes (Fig. 6, 7).

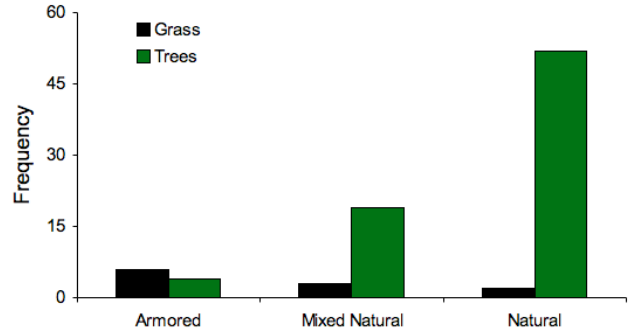
Figure 6. Frequency of photos with shorelines characterized by riprap revetments or vertical bulkheads (“armored”), mixed natural and armored (“mixed natural”), and unarmored shorelines (“natural”) where upland areas were dominated by trees or lawns (“grass”).

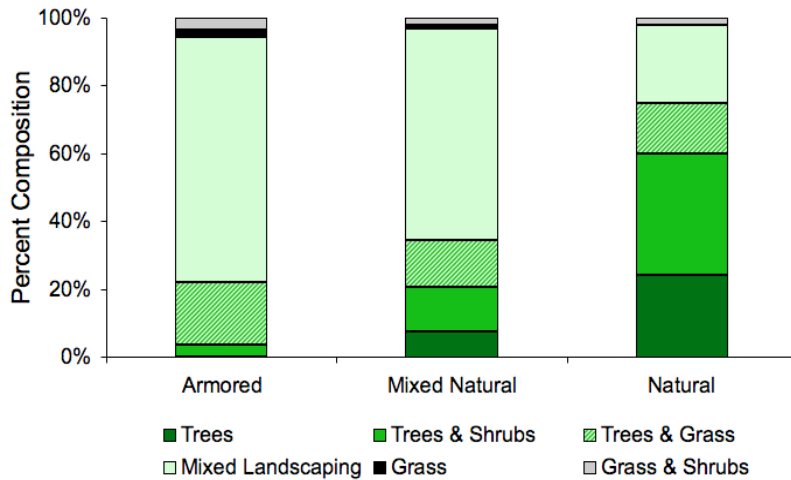
Figure 7. Percent composition of upland areas for photographs where the predominate shoreline type was riprap revetment or vertical bulkhead (“armored”), armored and natural shorelines (“mixed natural”), or unarmored shorelines (“natural”).

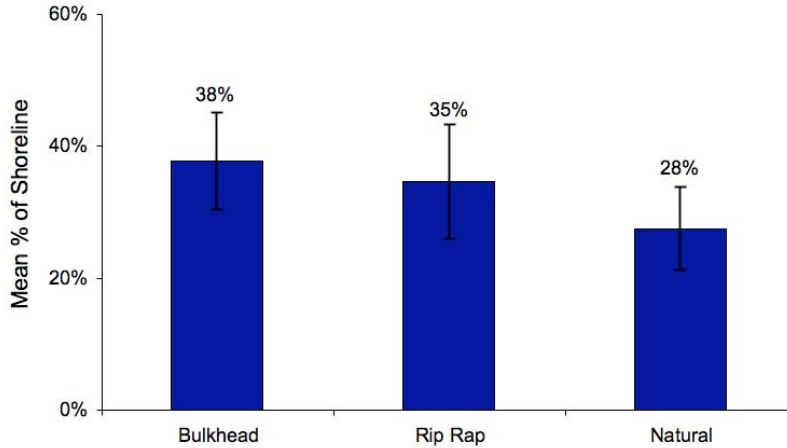
Figure 8. Percent of total shoreline measured in the 16 selected WRIA 9 photos taken December 2006 that were characterized by vertical bulkheads (“bulkhead”), riprap revetments (“riprap”), or unarmored shorelines (“natural”). Error bars represent the standard error of the mean.

vertical bulkheads. More than 70% of shorelines were equally armored with riprap revetments or vertical bulkheads and, of the shorelines we measured, only 28% were unaltered (Fig. 8). Logs were significantly more abundant on unarmored shorelines ( $F_{2,34} = 12.9$ ,  $P < 0.001$ ) and least abundant on beaches with vertical bulkheads (Fig. 9).

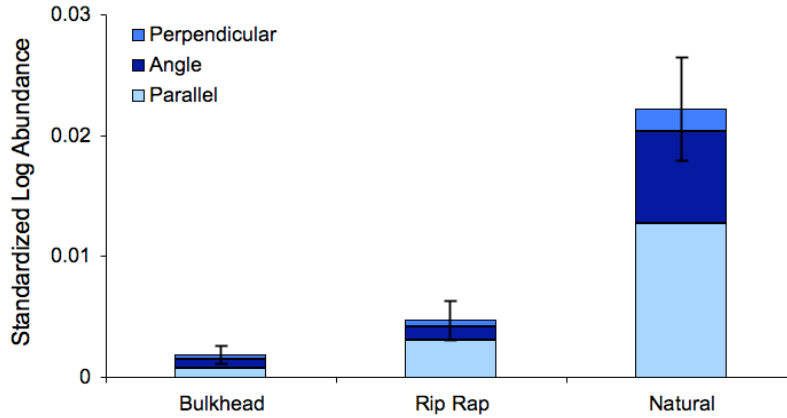
Figure 9. Mean standardized log abundance (logs per segment length) of shorelines characterized by vertical bulkheads (“bulkhead”), riprap revetments (“riprap”), or unarmored shorelines (“natural”); mean abundances are shown for logs positioned perpendicular to the shoreline (med blue), at an angle to the shoreline (dark blue), or parallel to the shoreline (light blue). Error bars represent the standard error of total mean abundance. Data are from analysis of 16 selected WRIA 9 photos taken December 2006.

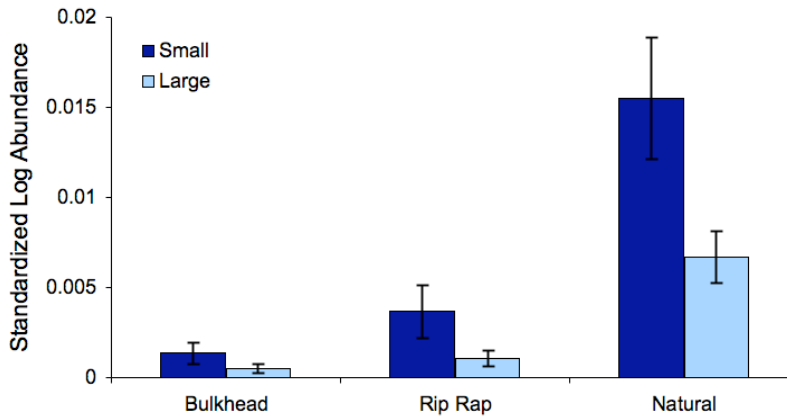
Figure 10. Mean standardized log abundance (logs per segment length) of small (blue) and large (light blue) logs observed along shorelines characterized by vertical bulkheads (“bulkhead”), riprap revetments (“riprap”), or unarmored shorelines (“natural”). Error bars represent the standard error of the mean. Data are from analysis of 16 selected WRIA 9 photos taken December 2006.

Patterns in log position relative to the shoreline were only slightly influenced by shoreline armoring; although logs were most often positioned at oblique angles on bulkheaded shores (43%), on riprap-armored and natural shorelines most logs were positioned parallel to the shoreline (57-65%), followed by logs at oblique angles. Only 8-12 % of observed logs were perpendicular to the shore (Fig. 9). Both small and large logs were significantly more abundant on unarmored shorelines ( $F_{2,34} = 12.0$ ,  $P < 0.001$ , and  $F_{2,34} = 12.9$ ,  $P < 0.001$  respectively; Fig. 10). Small logs composed the majority of LWD on beaches and accounted for 70 – 78% of logs at each shoreline type; large logs were proportionately more abundant on unarmored shorelines than bulkheaded or riprap armored shores (Fig. 10). Lastly, the area occupied by LWD was significantly higher on natural shorelines than armored shorelines ( $F_{2,34} = 5.3$ ,  $P=0.01$ ), and was most variable along shorelines with vertical bulkheads (Fig. 11).

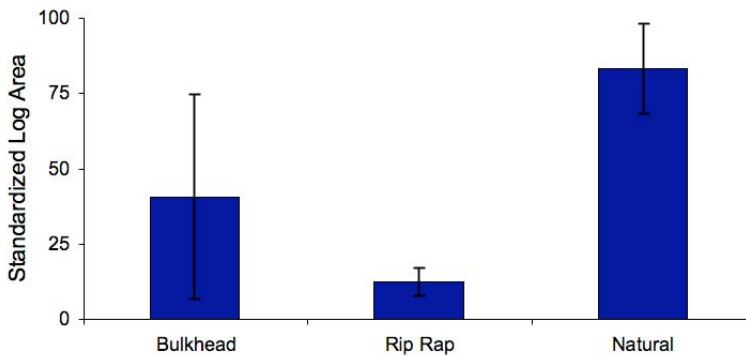
Figure 11. Mean LWD area standardized by shoreline segment length along shorelines characterized by vertical bulkheads (“bulkhead”), riprap revetments (“riprap”), or unarmored shorelines (“natural”). Error bars represent the standard error of the mean. Data are from analysis of 16 selected WRIA 9 photos taken December 2006.

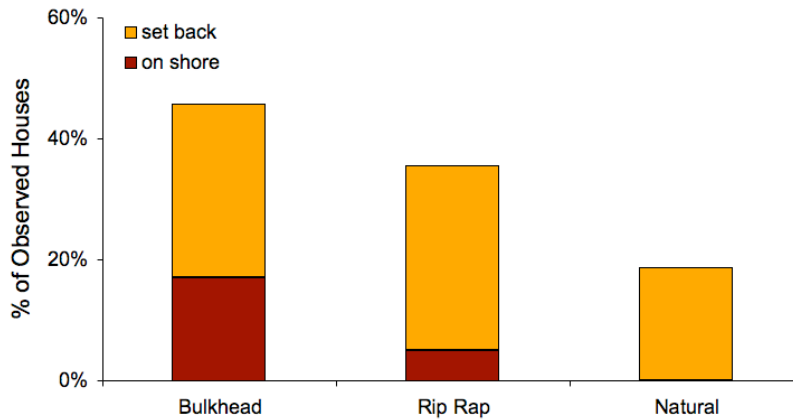
Figure 12. Percentage of all observed houses either directly adjacent to the shoreline (“on shore”; red) or located in the upland behind the shoreline (“set back”; orange) that occurred along shorelines characterized by vertical bulkheads (“bulkhead”), riprap revetments (“riprap”), or unarmored shorelines (“natural”). Data are from analysis of 16 selected WRIA 9 photos taken December 2006.

Every shoreline segment armored with riprap had at least one house upland from or adjacent to the shore, as did 96% of shoreline segments armored with vertical bulkheads and 58% of unaltered shoreline segments. The majority of residential houses and buildings were observed along armored shorelines, with only 19% of houses observed along natural shorelines (Figure 12). In addition, every house observed along natural unarmored shorelines was set back from the shore; houses that occurred in close proximity to the shore always had vertical bulkheads or riprap revetments.
