## **LARGE-SCALE PATTERNS IN LARGE WOODY DEBRIS AND UPLAND VEGETATION AMONG ARMORED AND UNARMORED SHORELINES OF PUGET SOUND, WA.**

Dr. Kirstin K. Holsman  
*People For Puget Sound, Seattle*

Justin Willig  
*School of Aquatic & Fishery Sciences, University of Washington*

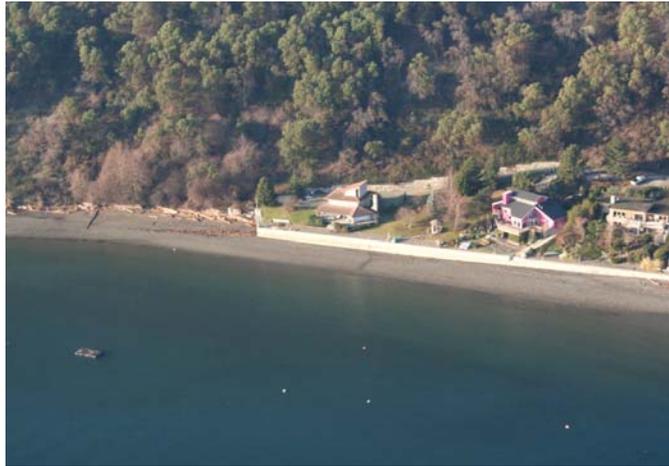
Figure 1. Image of natural (on left) and armored (right) shorelines.
