# Cherry Creek Floodplain Reconnection – Phase II

## Project Overview

Snoqualmie Valley Watershed Improvement District (SVWID)

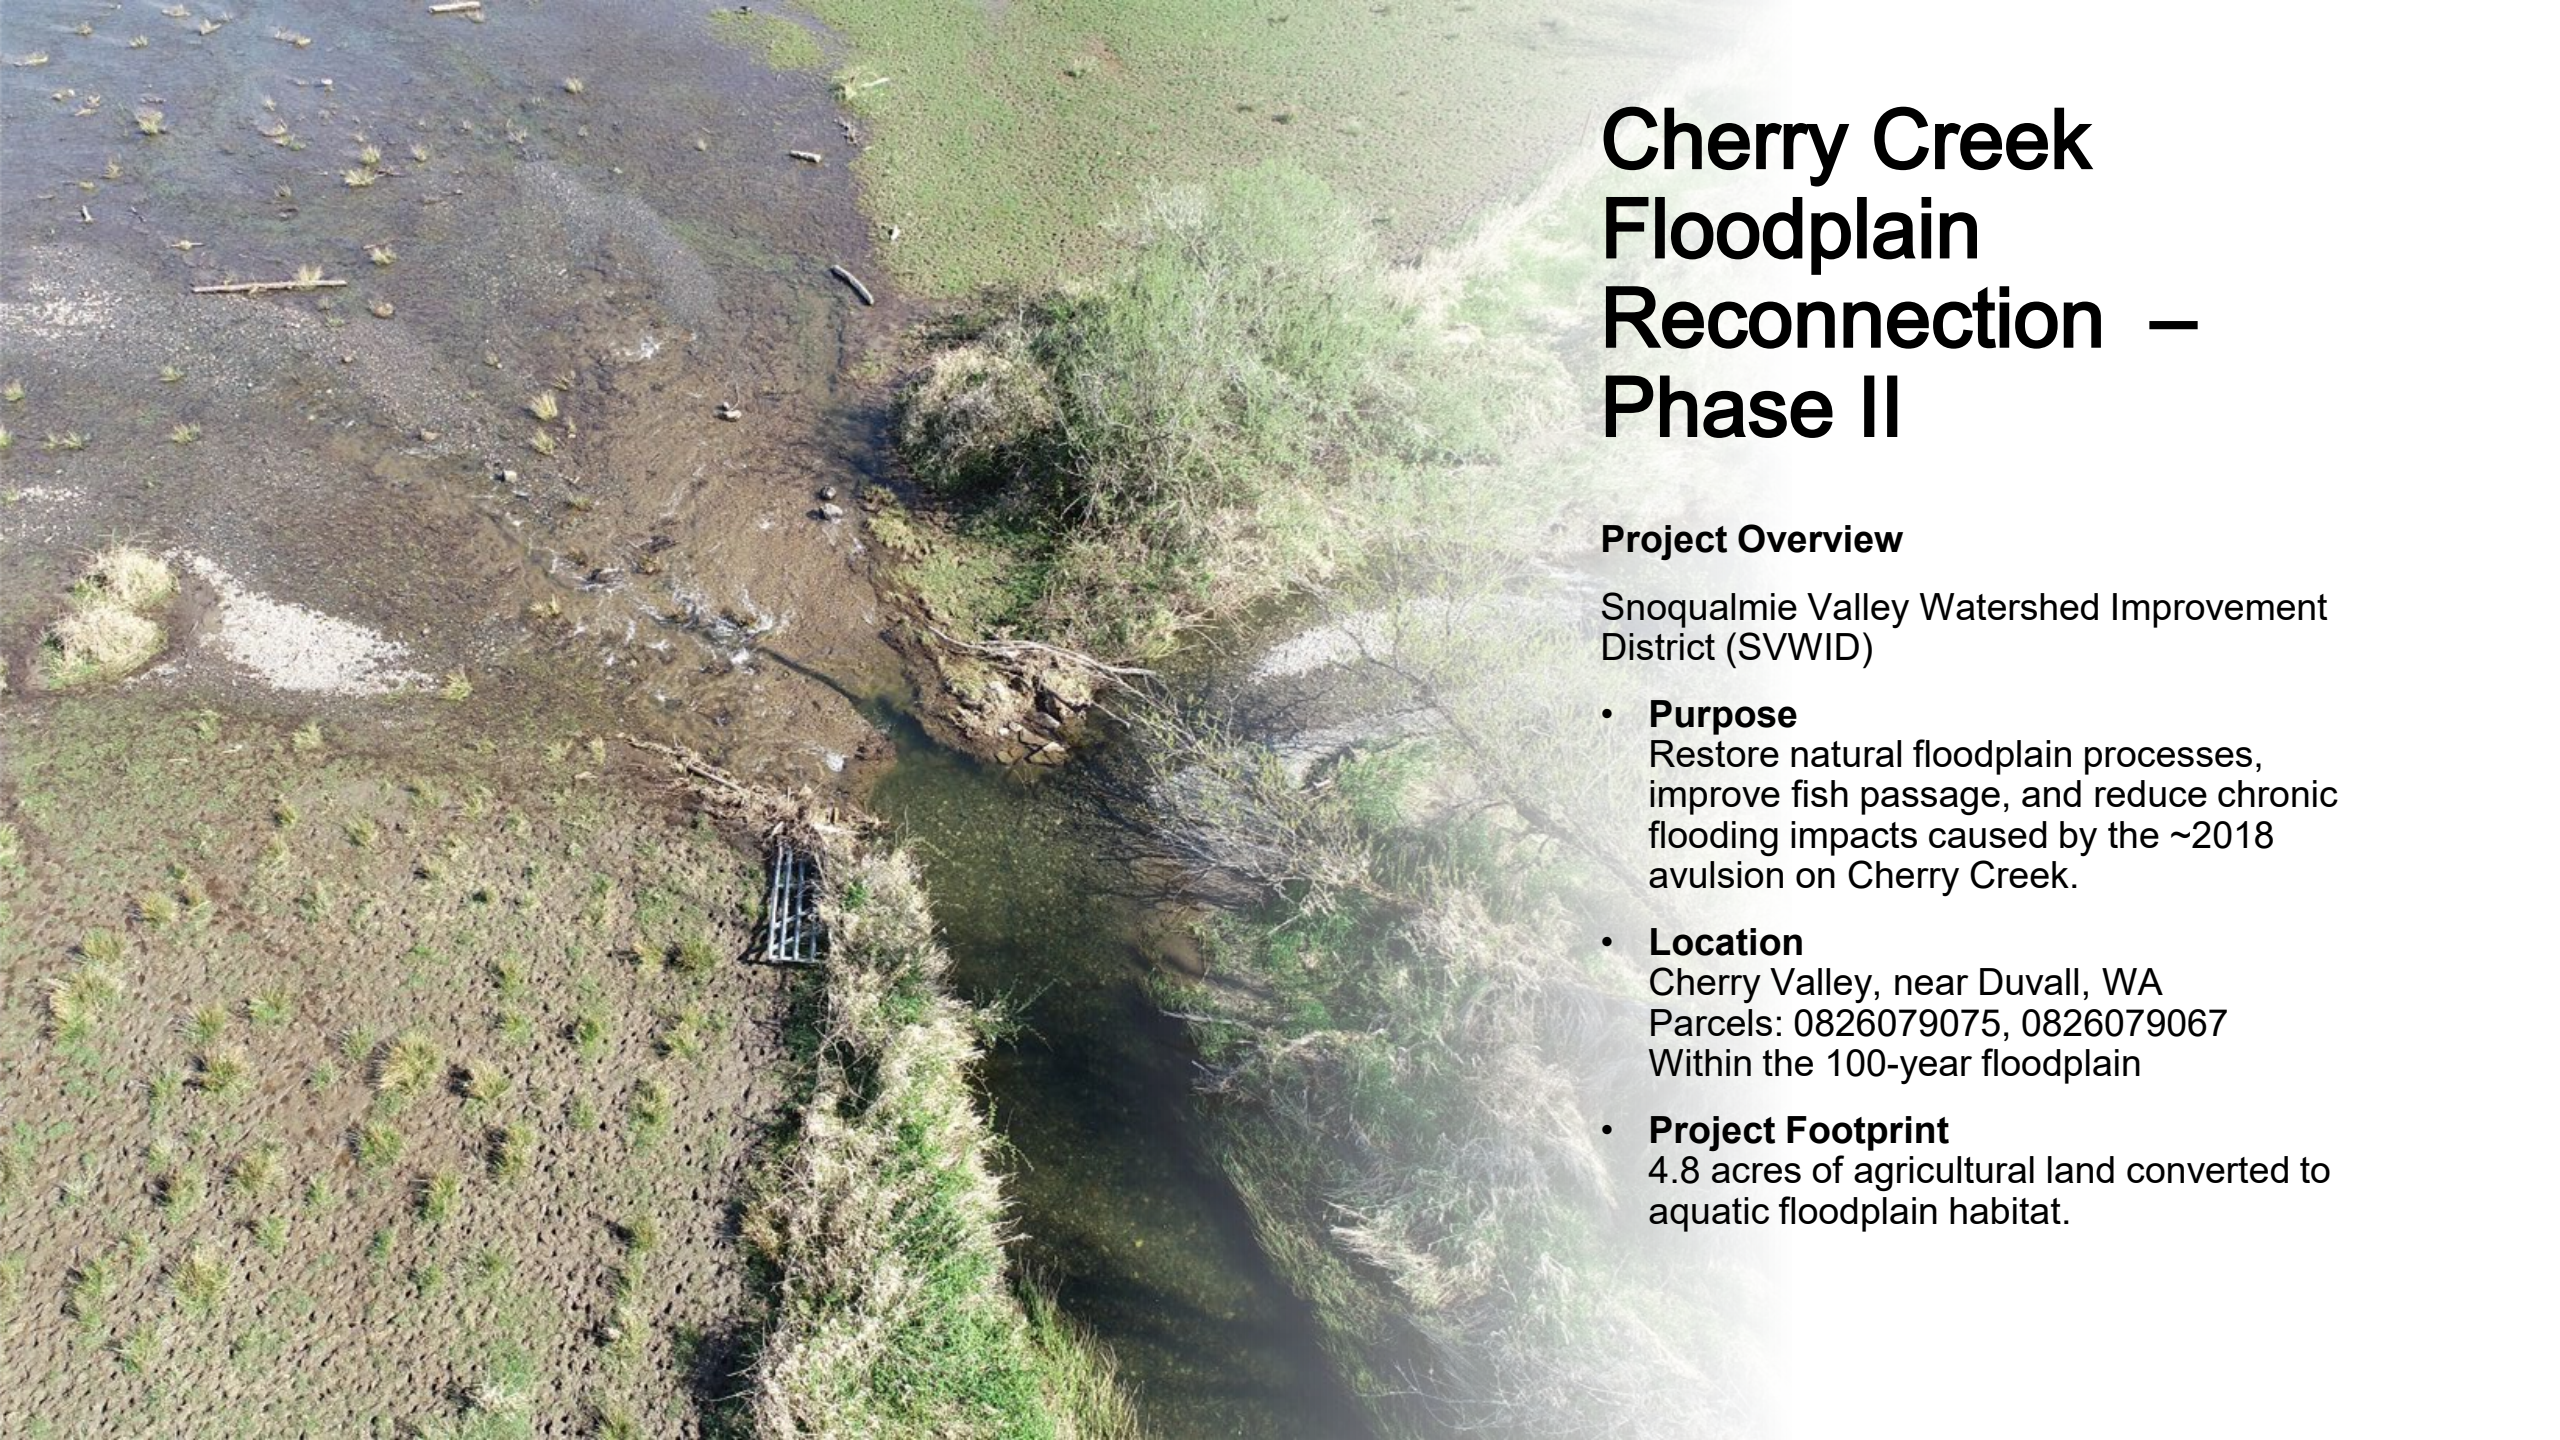
An aerial photograph of a river channel. In the lower-left foreground, a metal grate is visible in the water. The river flows from the top-left towards the bottom-right. The left bank is a mix of dark, silty water and patches of green grass. The right bank is a steep, grassy embankment with some exposed roots. The background shows a wide, flat area of land, likely a floodplain, with a mix of green vegetation and bare earth.

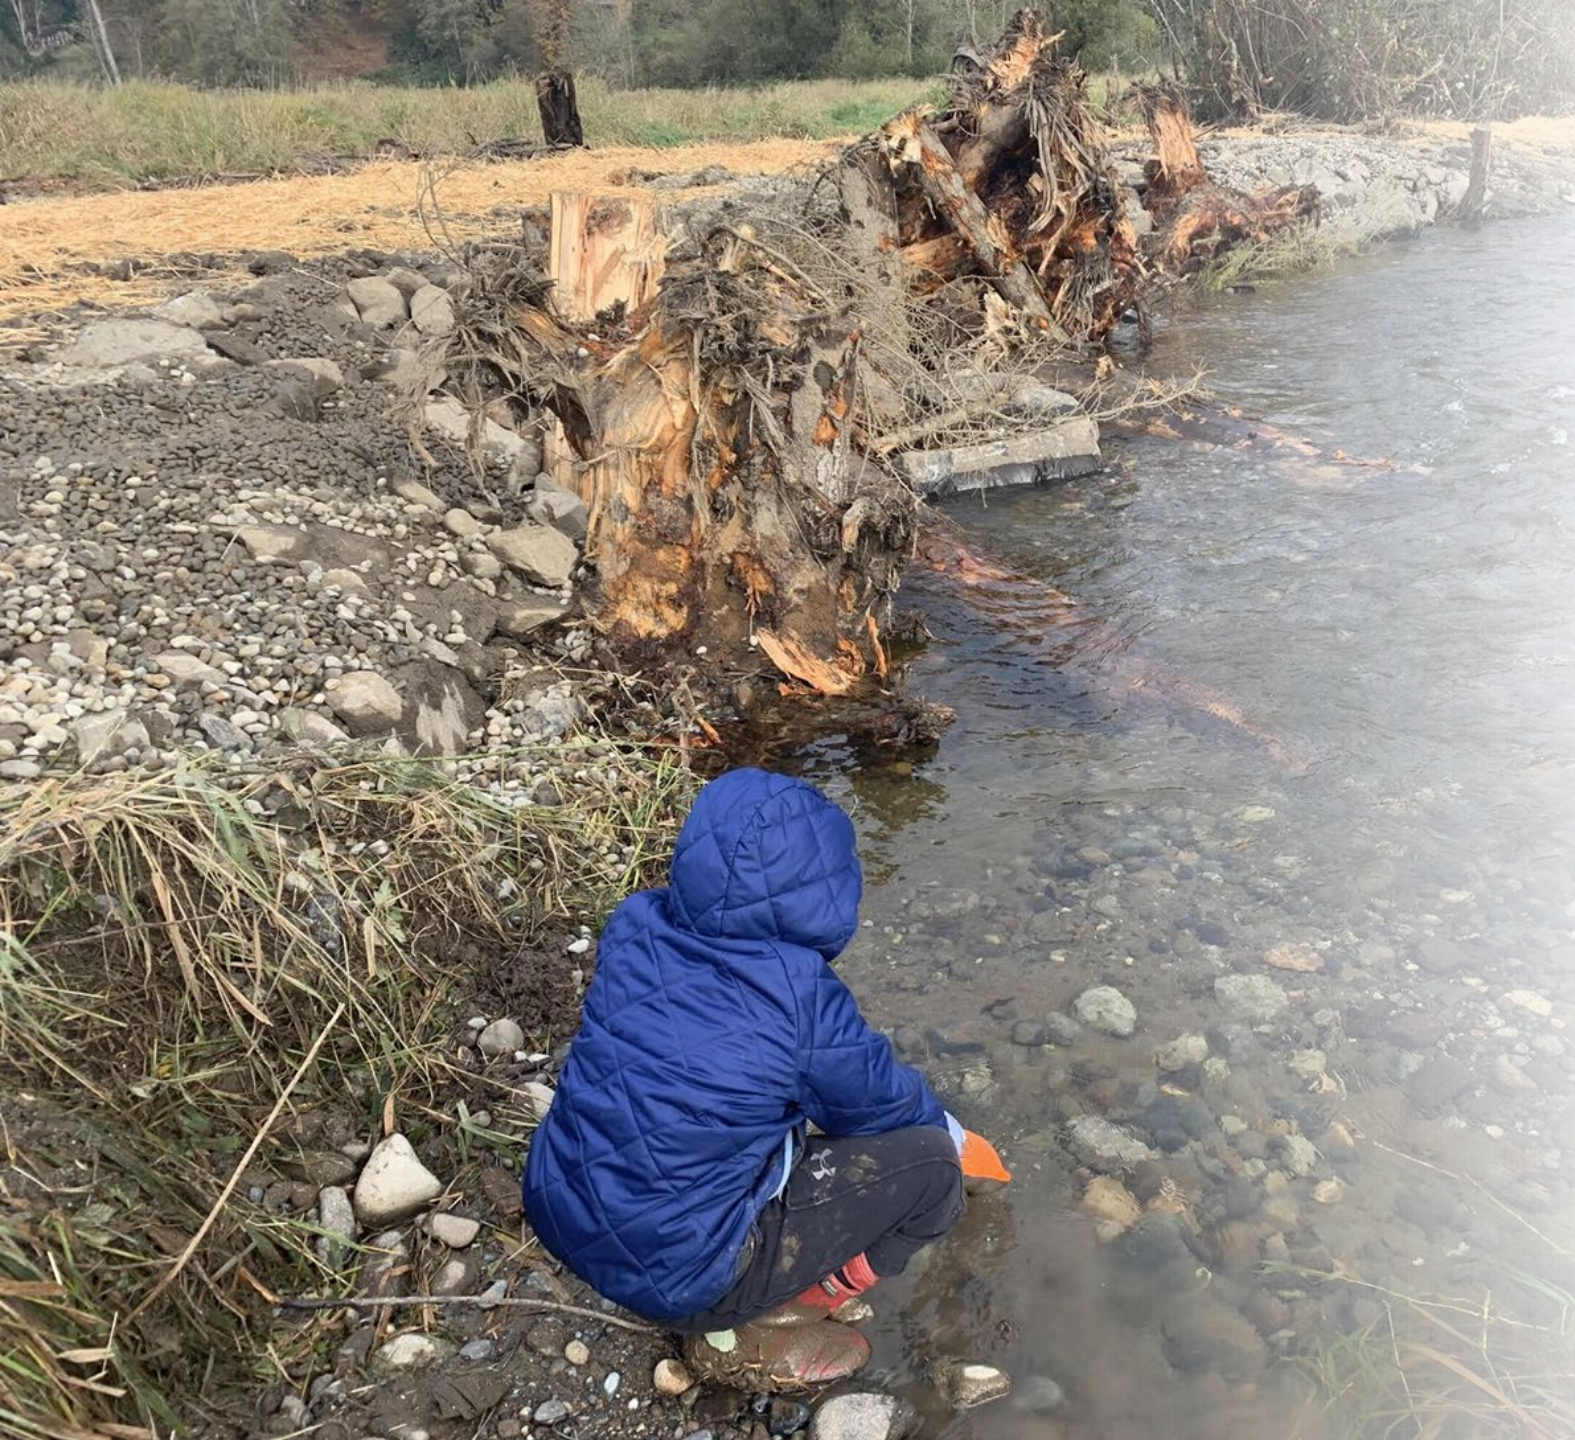
A photograph of a person wearing a blue hooded jacket and dark pants, crouching on a rocky bank next to a stream. A large, weathered log is partially submerged in the water, acting as a barrier. The stream flows from the background towards the foreground. The background shows a grassy field and some trees.
