## Restoration Monitoring in South Lake Washington

Roger A. Tabor, U.S. Fish and Wildlife Service  
Monica Shoemaker, Washington Department of Natural Resources  
Joe Starstead and Katherine Lynch, City of Seattle

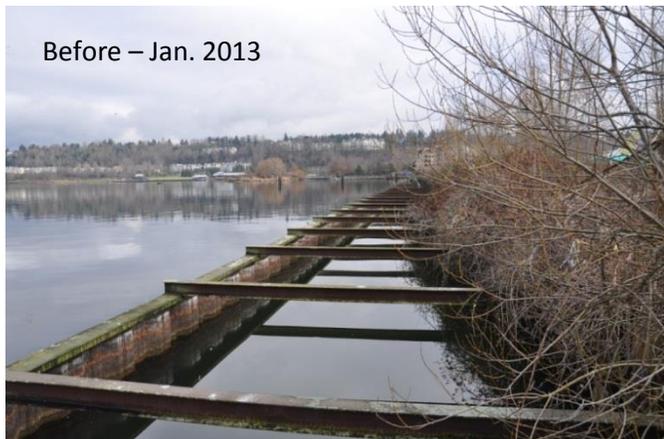
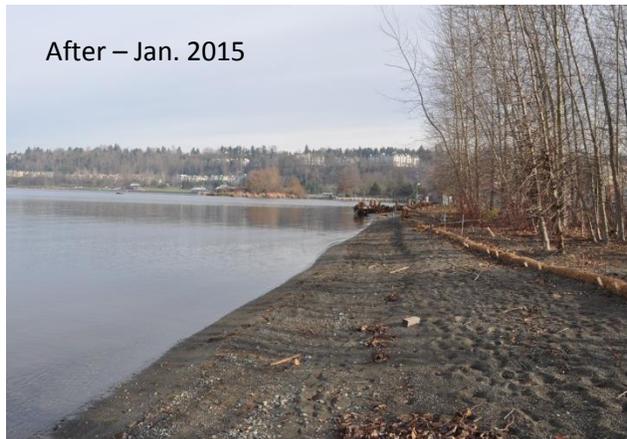
In the summer of 2014, WDNR removed most of the Shuffleton Power Plant flume structure and replaced it with a gentle-sloping sand/gravel beach (see above photos) and engineered log jams (ELJs). The flume was built to help cool water from the adjacent power plant. The power plant has been torn down and thus the flume structure was no longer used.

The structure was also only about a half of a kilometer from the mouth of the Cedar River. This restoration site is relatively large in comparison to other potential restoration sites; the part of the flume structure removed was about 150-m long and is part of a 360-m long shoreline section owned by WDNR. The flume structure consisted of two parallel, vertical steel walls that resulted in poor habitat conditions (i.e., little shallow water, no sand and gravel substrates, and little structural complexity) for juvenile Chinook salmon.

**WDNR Shuffleton Power Plant flume site.**-- Because good numbers of juvenile Chinook salmon (i.e., > 40 fish on each survey night) were observed along the old flume transect in 2015 and their density was similar or higher than control sites, removal of the flume structure and replacing it with a sandy beach appeared to create valuable habitat for juvenile Chinook salmon. This site should be particularly valuable for juvenile Chinook salmon because it is close to the mouth of the Cedar River, the source from which large numbers of Chinook salmon fry emigrate in the winter and early spring. The old flume wall structure is a good example of a suboptimal habitat: little shallow water, no sand and gravel substrates, steep slope, and little structural complexity (Tabor et al. 2011). The restored nearshore habitat now has a large area of shallow water < 1 m deep, primarily sand and gravel substrate, a gentle slope, and some nearby engineered log jams for refuge. Monitoring of the WDNR restoration will continue in 2016 and 2017.
